Original Research

Four buildings and a flush: Lessons from degraded water quality and recommendations on building water management

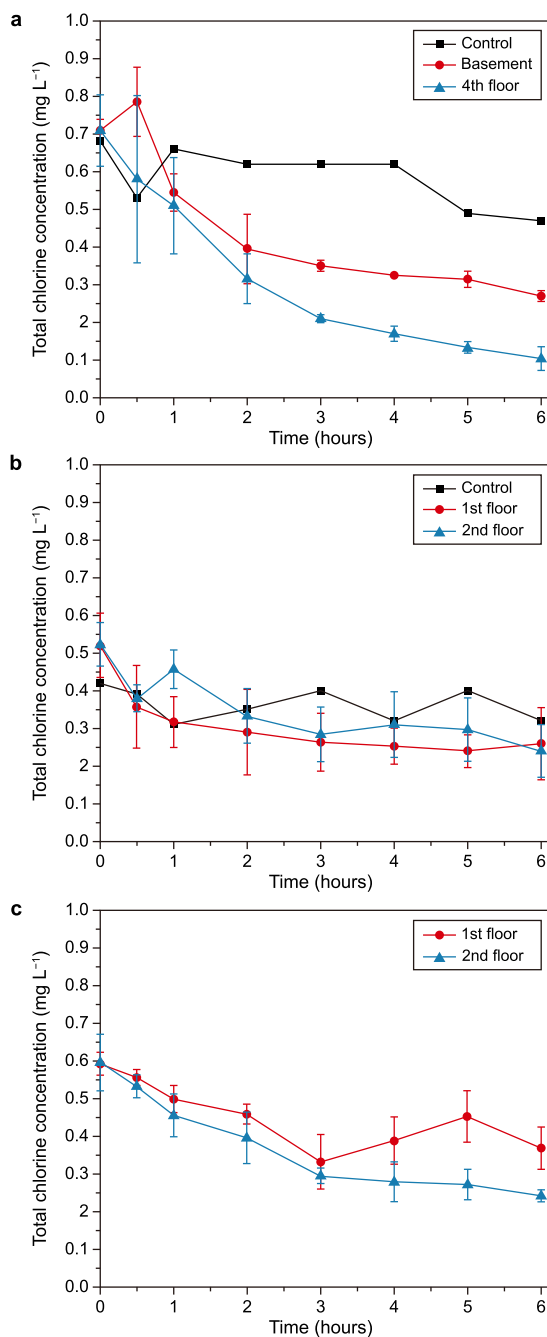
Chlorine residual decayed faster at fixtures on the upper floors than found at fixtures on the lower floors, which were closer to the water entry point in a large building (Fig. 4). The chlorine decay experiment was conducted in buildings A, B, and C when the buildings were back to normal operations (November). Generally, across most fixtures, floors, and buildings, no chlorine decay differences were observed. Concentrations remained above 0.2 mg L^{-1} as Cl_2 for 6 h when pre-stagnation concentrations were 0.4 mg L^{-1} as Cl_2 (Fig. 4). For two locations in building A, chlorine decayed to less than 0.2 mg L^{-1} as Cl_2 after only 4 h. Other investigators have found faster [12,60] and slower [34] chlorine residual decay inside healthcare, office, and university buildings.

Fig. 4. Total chlorine concentration (as Cl_2) decayed over 6 h at various fixtures within building A (**a**), building B (**b**), and building C (**c**). Building D did not have detectable chlorine residual at the service line even after flushing for 2.08 h. For the control, 1 L of water was collected on the 1st floor in buildings A and B and analyzed over the same period to determine if the plumbing affected the disinfectant decay rate.
